National Register of Historic Places Registration Form

Martin Blume Jr. Farm
Section number _	7	Page _	1_	Allen County, Indiana

Narrative Description

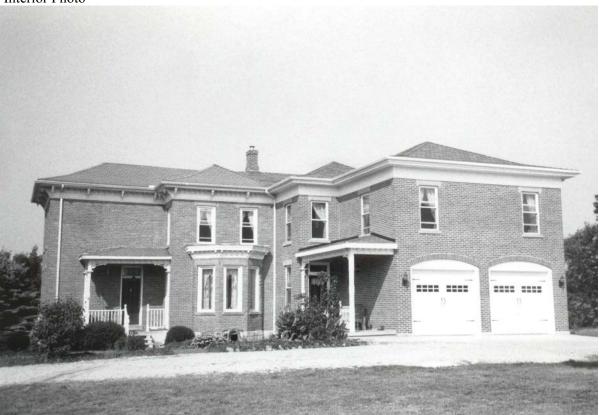
Photo 1

- 6. Camera facing northwest; farmhouse east elevation with recent addition to the right
- 7. Photograph number -1
- 1. Martin Blume Jr. Farm; Southwest corner of farmhouse

A recent addition was added to the house in 2004. The addition stretches the house eastward and includes a two car garage, mud room and half bath downstairs and a new master bedroom suite and sitting room upstairs above the garage. (Photos 1 & 3) Details of the original house are matched as closely as possible. For example the exterior door in the kitchen was saved and reframed in the new porch. The garage doors are two separate doors with an old fashion carriage house appearance. The second porch was included to mirror the original porch and flank each side of the bay windows to achieve architectural balance. (Photo 1)

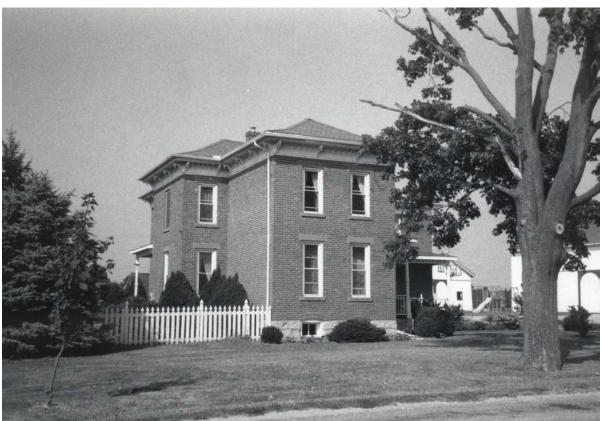
Photo 2

- 2. Allen County, Indiana
- 3. Brad Hively
- 4. 9-23-05
- 5. DHPA, 402 W. Washington St., W274, Indianapolis, IN
- 6. Camera facing northeast; with barns in the distance to the right

On the exterior, each of the doors has an accompanying transom window above. All the windows in the house have a rectangular limestone header above and footer below. The porch columns include very decorative cutout wooden brackets. (Photo 22) The south elevation of the house features two porches and ten large double hung windows. (Photos 1 & 2) The downstairs windows to the west open to the parlor and the upstairs windows to the west open up to bedrooms. All the first and second story double hung windows in the house are vinyl replacement windows. All the basement windows are original wood windows. There is a door on the southeast porch, which opens into the dining room. (Photo 14) All four exterior doors are original solid wood with three of them having a glass upper half with upper radius corners. The east elevation also features the same two porches and includes a large bay window from the dining room. (Photos 1 & 12) The southern door on the southeast porch opens into the parlor and the door to the north of the bay windows opens to the mudroom. Unique ornate brackets adorn the perimeter of the dining room bay windows. (Photo 13) The upstairs windows open to bedrooms and two

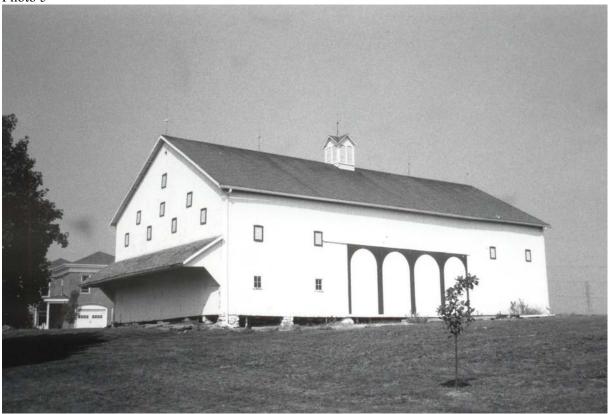
Photo 7

The property includes many out buildings. The grandest of these is the large timber frame threebay threshing barn, with post-and-beam construction. (Photo 7) The location of this large structure is due east of the farmhouse. This large barn dates to c.1883 and measures 80' long by 40' wide and 40' tall. The timber frame construction with its mortise & tenon and wood peg joinery, is an excellent living example of 19th century regional building techniques. This large structure is constructed from hand hewn native oak timbers measuring up to 40 feet long and vertical cedar board siding. The gable roof has a steep pitch of 45 degrees. Portions of the original cedar shake roof are still present inside the barn under a more recent asphalt shingle roof. Eight large horizontal sliding doors measuring 12' x 8', provide access through the barn in the center of the east and west sides. The cupola on top of the barn provides excellent ventilation. At the peak of the gable ends is a decorative owl hole for barn swallows and additional ventilation. An old water cistern still exists in the south end of the barn next to the animal stalls. Above the animal stalls is a hayloft. The loft floor has wood planks, which measure up to 20" wide. A hay bail track and equipment is also present inside along the entire ridge board. The vastness of the internal space was obviously invaluable for threshing grain, storing hay & straw and protecting animals year round.

- 6. Camera facing northwest; large barn with farmhouse to the left
- 7. Photograph number 7
- 1. Martin Blume Jr. Farm; View of hog barn and storage barn

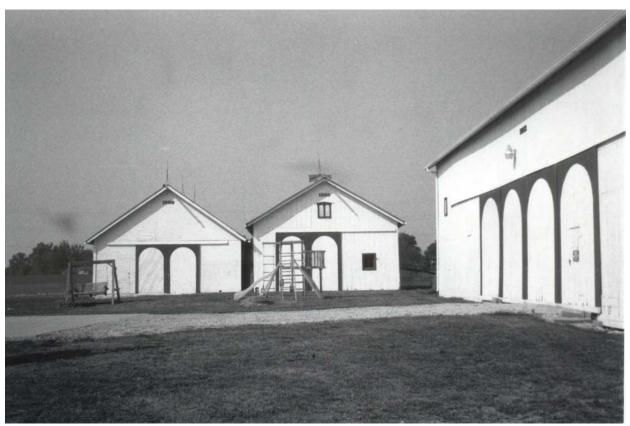
Photo 8

Northwest of the threshing barn is a smaller barn also constructed of timber frame building techniques. (Photo 8) This barn measures 33' x 24' and dates to c.1889. Raising and breeding of hogs was probably the main purpose for this structure, since remnants of a corncrib still exist inside along the west wall and evidence suggests the presence of a larger corncrib directly to the north. This barn is also adorned with a small cupola and is constructed from native oak timbers and vertical cedar sideboards. Two horizontal sliding doors provide access on the south side. And another sliding door is present on the north gable end. The foundation is a stone and concrete footer with an earth floor. The original roof was cedar shake, however the current roof is galvanized sheet metal.

Directly west of the hog barn is a storage barn which measures 34' x 24'. (Photo 8) This barn dates to c.1899 and is constructed from a more modern balloon frame technique. The structural members of this barn are rough sawn oak. The flooring in this building is tongue and groove wood boards. Currently the roof on this structure is also galvanized sheet metal.

- 2. Allen County, Indiana
- 3. Brad Hively
- 4. 9-23-05
- 5. DHPA, 402 W. Washington St., W274, Indianapolis, IN
- 6. Camera facing north; hog barn and storage barn with large barn to the right
